# Repowering an I-36

13 August 2006 - 26 October 2006

## Repowering an Islander 36 sailboat

by John Hamlet

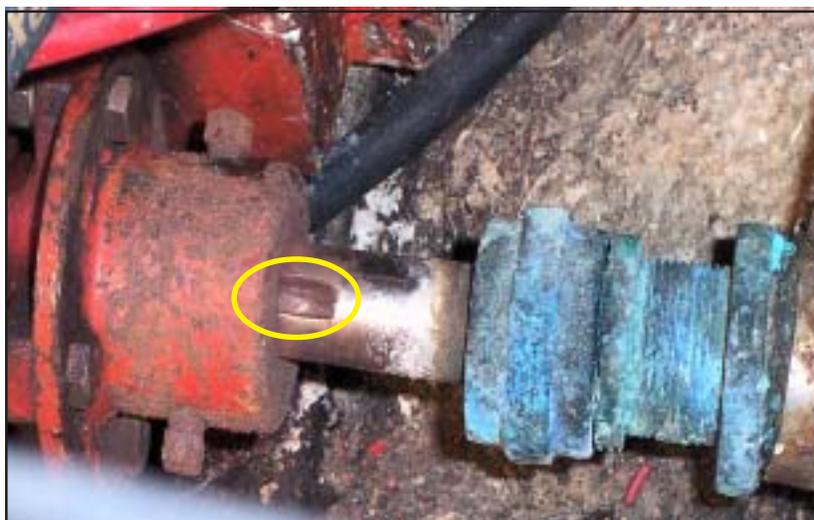
Figure 1 - Shaft coupling missing key

I examined the engine compartment and found that the prop shaft coupling key was missing. Elated that this was the cause for our loss of motive power, although puzzled by the presence of speed in reverse, I installed a new shaft key. The coupling had some play around the shaft and I could feel the remains of the old key as I turned it. I then observed the shaft rotate at various speed while moored in our slip. It seemed that reverse turned the shaft faster than forward, but both moved Charisma in the slip. We tested my shaft key fix the next weekend.

Later, I would learned that both the shaft and stuffing box needed replacement due to keyway wear and tube age.

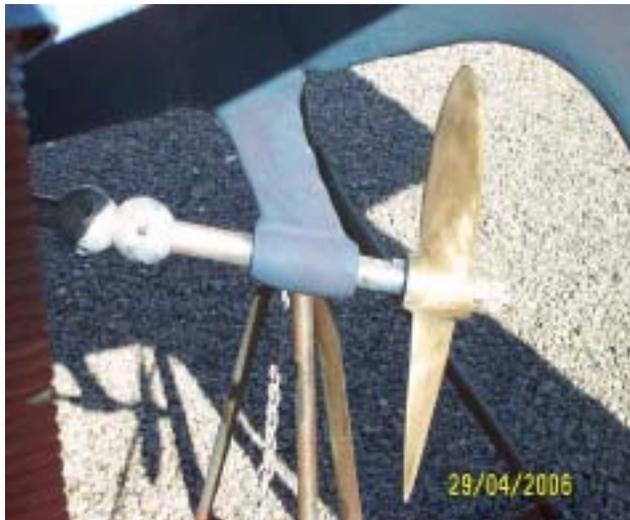
**Figure 3 - Before prop**

The old two-bladed, 14 inch prop was deemed insufficient for 40 HP. A fixed, 3-bladed, 14 inch prop, was ordered due to the limited shaft-rudder clearance. Calculations indicated a 3-bladed, 18 inch diameter prop with 11.8 inches of pitch was ideal, but we did not want to replace the shaft strut. Moreover, the yard foreman told me it was important to keep the shaft depression angle shallow for the sake of the engine orientation. A local prop shop adjusted the 14 inch prop's pitch to 14 inches.

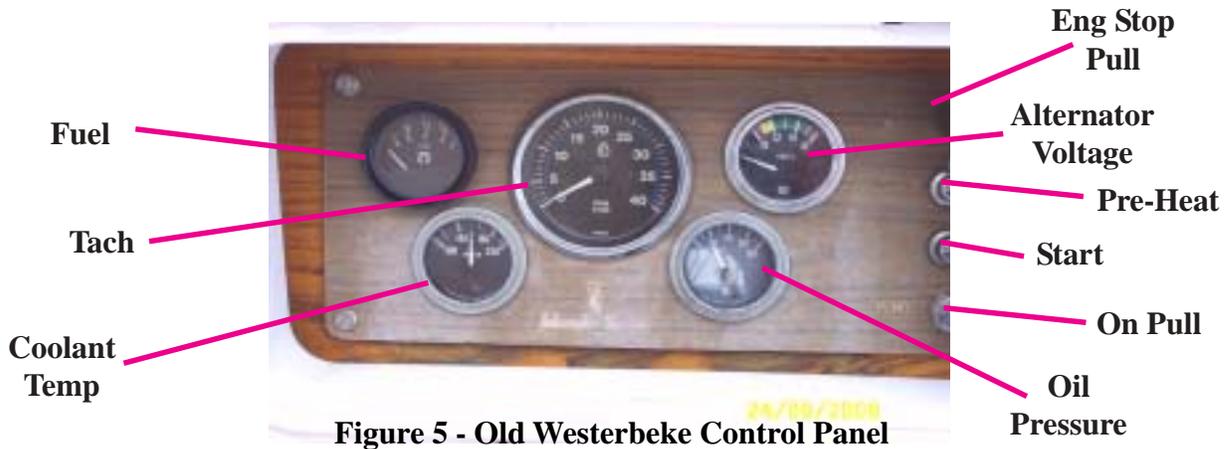
The Yanmar is metric. The new temperature and oil pressure gauges were difficult to read because each has both Metric and English units. I opted for these gauges (C-type panel) which do not come standard (B-type panel). I also had recently replaced our original fuel gauge. Note that the new Yanmar panel has no fuel gauge! The yard mounted both our old DC voltmeter and fuel gauges beside the standard Yanmar panel in the original panel enclosure. This Yanmar diesel used no glow plug. The key switch uses two positions - ON and OFF. No preheating is necessary. The ignition position “GLOW” was a “leftover” caused by reuse of an engine panel from another Yanmar model. The key switch has a plastic cap to keep out water. To stop the engine, one presses the STOP button. Only the Low Battery “icon” light at the top of the panel is functional. The other icon lights for seawater flow, water in fuel filter, and water in sail drive are non-functional on the 3JH4E model.

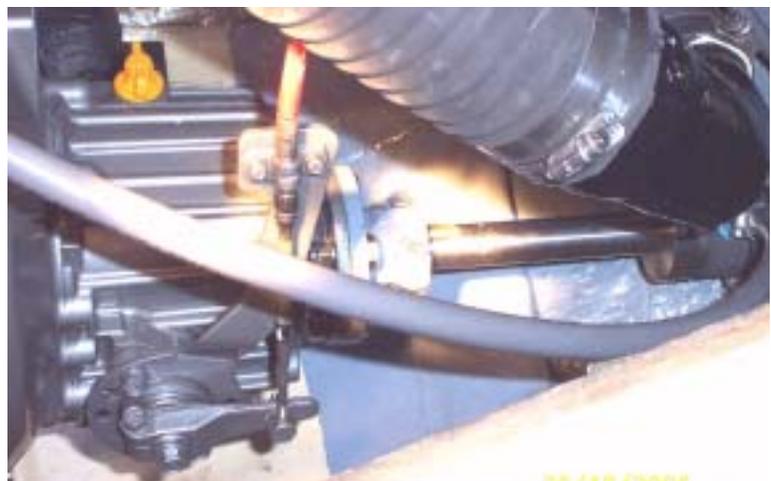
**Figure 8 - Kansaki transmission**

The transmission is a Kansaki KM35P made in Japan for Yanmar. It has 2.36 reduction ratio in forward and 3.16 reduction ratio in reverse. A mechanical cone clutch is used. Its lubrication system is a splash type with air cooling. The gear oil capacity is 1 pint. It uses SAE 30, single-grade, non-detergent motor oil. I expected ATF as the gear lubricant, but the Yanmar operation manual and dealer specified motor oil.
