Roller Furler Repair on an I-36

6 October 1999 - 4 August 2002

by John Hamlet, Captain - S/V Charisma

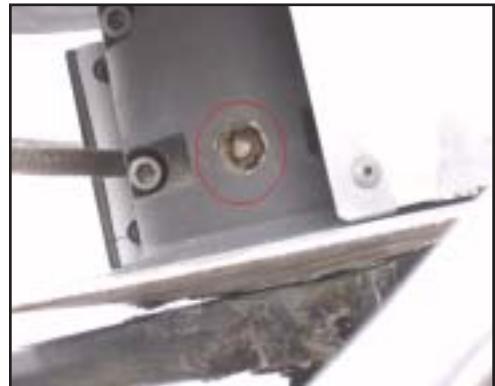
The first indication I had that our 1978 Islander's roller furling system might need serious repair came when I was recommissioning her in the spring of 2002. I had begun a routine of injecting grease into the roller furling drum after I had replaced two ball bearing assemblies in 1999. In the spring of 2002, while winding the roller furler foil to expose the grease fitting (shown in Figure 1), the jib halyard wrapped around the furler swivel at the top of the mast. I freed the halyard, unaware that the furler foil had cut into the jibstay cable strands. More on this oversight later.

Figure 1 - Furler grease fitting

As a consequence of this three weekend “adventure,” the injection of white lithium grease into the roller furler take-up drum now had become an annual maintenance action when I recommissioned Charisma each spring. For two years I furled and unfurled our genoa with ease. The previous binding at the take-up drum had disappeared. I was happy.... But, in a little over two years time, another roller furler “adventure” was in store for us.

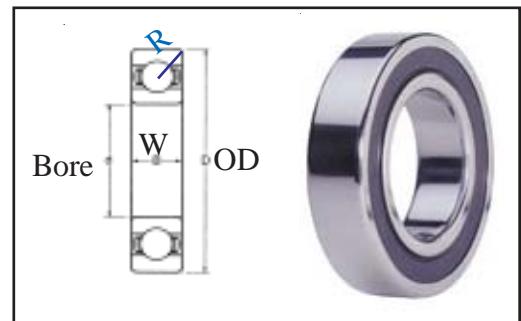
Upon our return to the marina, I worked up the courage to open the furler's take-up drum. It required a hex wrench to unscrew the drum bolts. I was surprised when about a dozen pebble-shaped iron peas fell on the deck. These odd sized pebbles did not resemble ball bearings. The take-up drum had rotated rough lately. Now, I understood why. I continued to disassemble the roller furler drum with the hex wrench and found two circular bearing assemblies - one at the bottom of the drum and a second at its top. There were two snap rings and two rubber O-rings securing the cylindrical jibstay shaft in the center of the drum. The bearing races were rusted through in places. When I cleaned and brushed a bearing race, I could discern the numbers "6208RS" and "Romania". I soon was to become a lot more knowledgeable about bearing assemblies and roller furler system construction.

I typed "6208RS" into the Google search engine and got several hits. "6208RS" translated into a "deep grooved", single row, rubber sealed, radial ball bearing assembly with the following bearing characteristics:

ID (inner diameter)/Bore = 40mm (1.57in)
OD (outer diameter) = 80mm (3.15in)
Width/Height/thickness = 18mm (0.71in)
Balls = 9, RS = rubber seal
Bearing Race Radius = 1.1mm (0.04in)

Figure 2 - 6208RS drum bearing

The "boundary dimensions" are shown in Figure 2. I ordered a set of two in stainless steel with a rubber seal on each side. Total cost was \$62.10. Removing and replacing the stainless steel retaining rings (Rotor Clip DSH-40) was the hardest part.

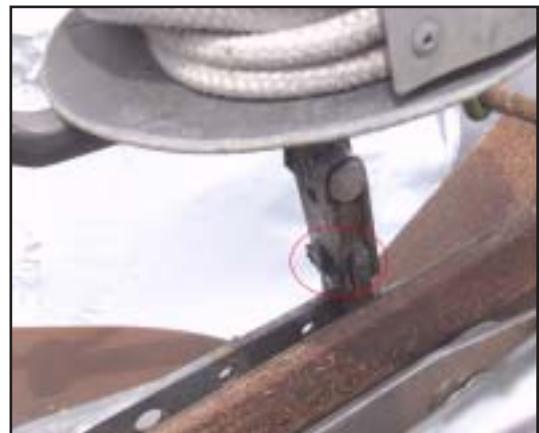
On May 26, 2002 my wife and I were exiting the Wye River on Maryland’s Eastern Shore. The main was up and I had just begun to unfurl the genoa when I noticed that the take-up drum had unscrewed from its bow swivel fitting. Quickly, we anchored out of the channel and dropped the main. We let the genoa fly as I began to assess the cause. I could not manually furl the genoa as I had done previously because the take-up drum was free from its mounting. I decided to release the halyard and lower the genoa by sliding it off of the roller furler foil. As soon as I began, I could see the entire roller furler foil was coming down. I winched the halyard back up into position. I removed the swivel pin from the take-up drum swivel at the bow; screw the swivel back into the base of the drum; and reattached the swivel to its bow fitting. Removing and reinserting the swivel clevis pin (See Fig 3) was no easy task with the genoa luffing in the breeze. It required a great deal of patience. I again released the halyard to gain some play at the swivel.

Figure 3 - Drum swivel clevis pin

Finally, I got the swivel pin in without dropping it overboard. Once the take-up drum assembly was reattached at the bow, I could not rotate the drum without unscrewing the swivel. So I unreeved the genoa sheets and manually wrapped the genoa around the foil. At this point I did not realize that the jibstay had parted. The backstay tensioner was eased to reduce the strain on the jibstay. We sailed “gently” under the main alone for two days to return to our marina.

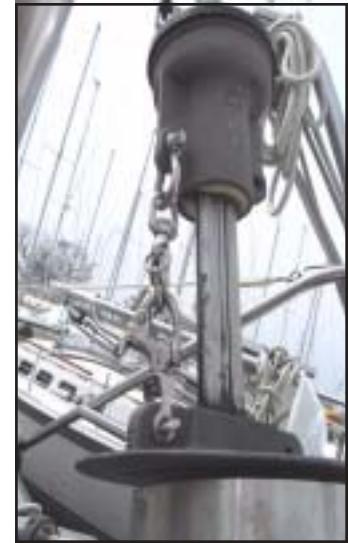
Figure 4 - Foil “car” attaches to genoa head

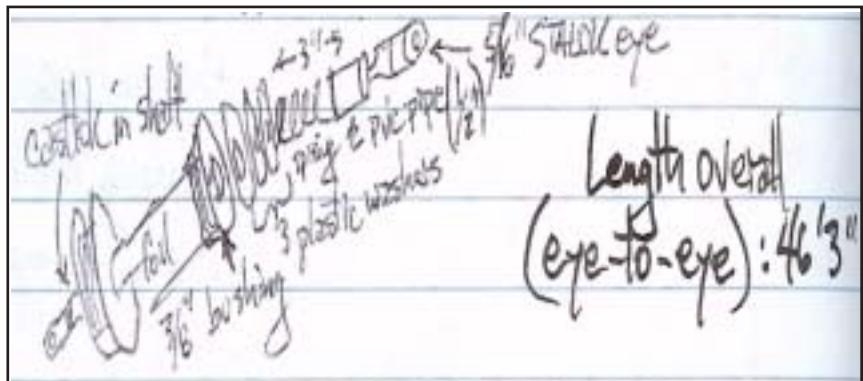
Figure 4 - Components at top of foil

I had to solve the problem with the top of the foil cutting into the cable strands before I threaded the cable back through the foil. I decided to epoxy a 3/8 inch thick plastic bushing to the top foil, add 3 plastic washers, thread on a 3 inch long stainless steel helical spring (Century Spring Corp. #72133S) to hold the foil down on the drum and away from the top eye terminal, and top it all off with a short length of 1/2 inch PVC pipe to enclose the spring. Getting the cable back through the eight foil sections required a lot of perserverance. Vise-Grip pliers and lithium grease helped. Each section was done separately; then each foil section was reconnected in turn. Another big sigh of relief was uttered when the cable finally appeared at the top of the last foil section. The plastic bushing was epoxied on the top and left for two days.

Then the three plastic washers were threaded over the cable, along with the spring. My original sketch of the arrangement is shown in Figure 4.

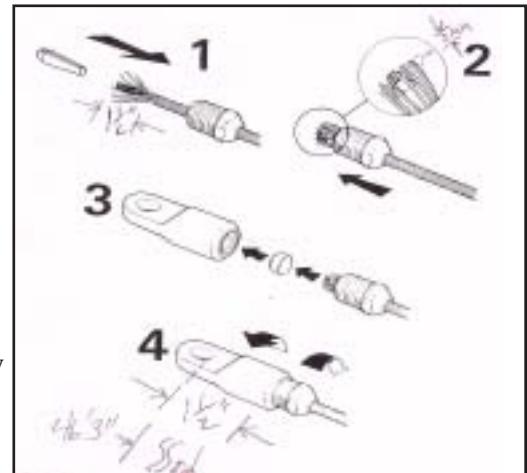
Figure 5 - Sta-Lok notes

I chose a Sta-Lok eye terminal to connect the jibstay cable to the eye at the top of the mast. The Sailing Services web site (<http://www.sailingservices.com/>) provided excellent instructions on the assembly of the Sta-Lok eye terminal. Probably the greatest challenge was deciding where to cut the cable. The old carpenter's adage - 'measure twice; cut once' applied. I knew if I cut the cable too short I'd have to start all over. If the cable were too long, I'd have to shorten it and hope to preserve enough to add a new eye terminal. I measured and re-measured the foil sections, old cable length, drum thickness, and the lengths of the eye terminal on each end of the cable. Finally, I decided to release the backstay tensioner; winch my wife up the mast (she actually likes that); and use a long windable measuring tape to measure from the masthead eye to the drum terminal eye, just to be doubly sure. 46 feet 3 inches - eye to eye was what was needed. I cut the cable allowing 1 1/2 inch for the assembly of the Sta-Lok eye terminal. My notes are shown in Figure 5. I put silicon caulk

inside the Sta-Lok fitting and applied Locktite to its threads. The foil was now reassembled and ready to go back up the mast. Slip neighbors helped carry the foil back aboard Charisma. I attached a long line to the top of the foil and winched my wife back up the mast streaming the hauling line. We hauled the top of the foil up to her where she inserted and secured the top swivel clevis pin. When I swung the base of the foil over to the bow toggle to insert the clevis pin, it was short by about 1 inch! I was worried that I had cut the cable too short. I verified that the backstay tensioner was released, but it would not allow the bottom swivel to line up so I could insert the clevis pin. A neighbor who was helping me placed his foot on the top of the take-up drum and with that action the clevis went into the swivel and toggle perfectly. I secured the cotter pin and breathed a huge sigh of relief.
