Islander Freeport (#4)

Swim Step Removal

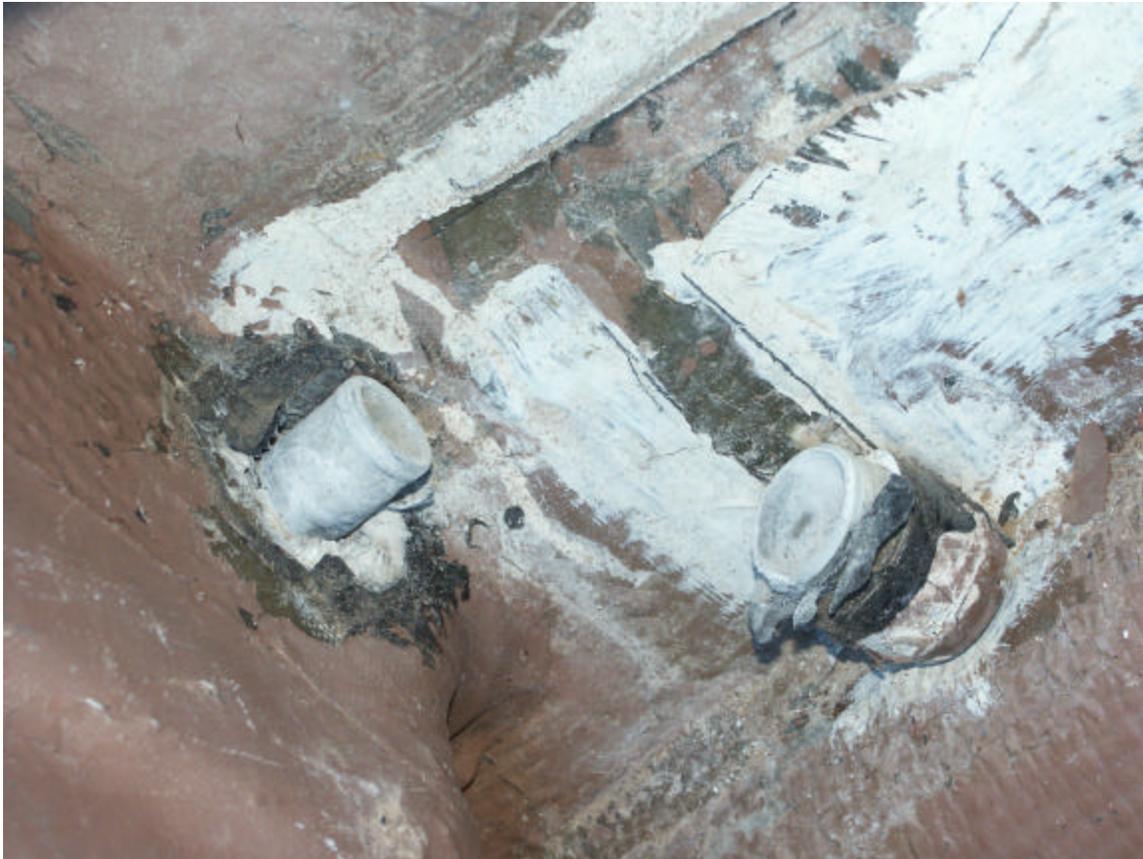
Inside of locker showing pipe from swim step with cap removed on right of picture. Note substantial amount of caulk/sealer, etc.

You will probably find a caulk build-up on the inside of the locker where the pipe enters into the boat through the through-hull fitting. Get a pair of large pliers or mol grips. Apply pliers or grips to the outside diameter and rotate counter clockwise. The cap will unscrew from the through-hull as the caulk breaks away.

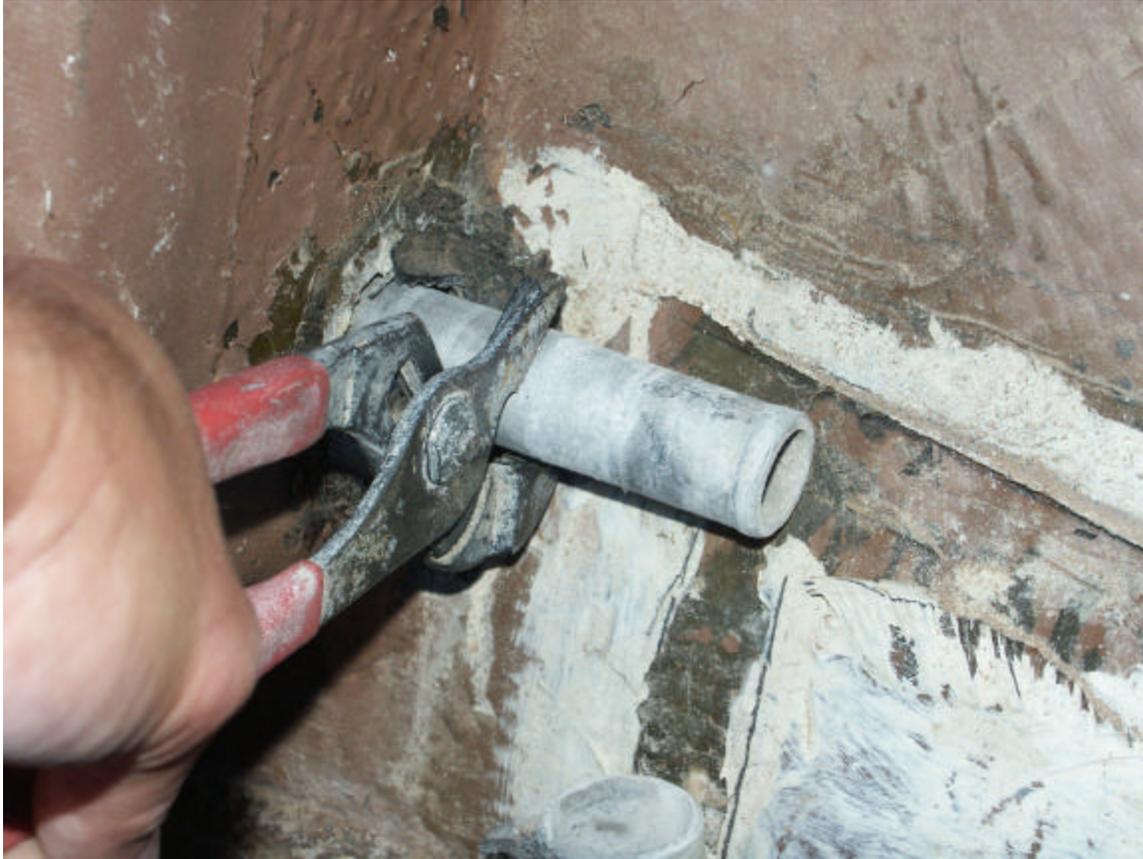
Removing pipe. (Turn and pull pipe through hull. You may need another person at other end to tap pipe with hammer and punch to push pipe through and disengage from through-hull on opposite side.)

When the caps are removed on both sides. Inset a punch and gently hammer the pipe through. Make sure you have somebody holding the swim step, because once the pipe clears the through-hull (where you are hammering) the swim step can be pulled out from one side.

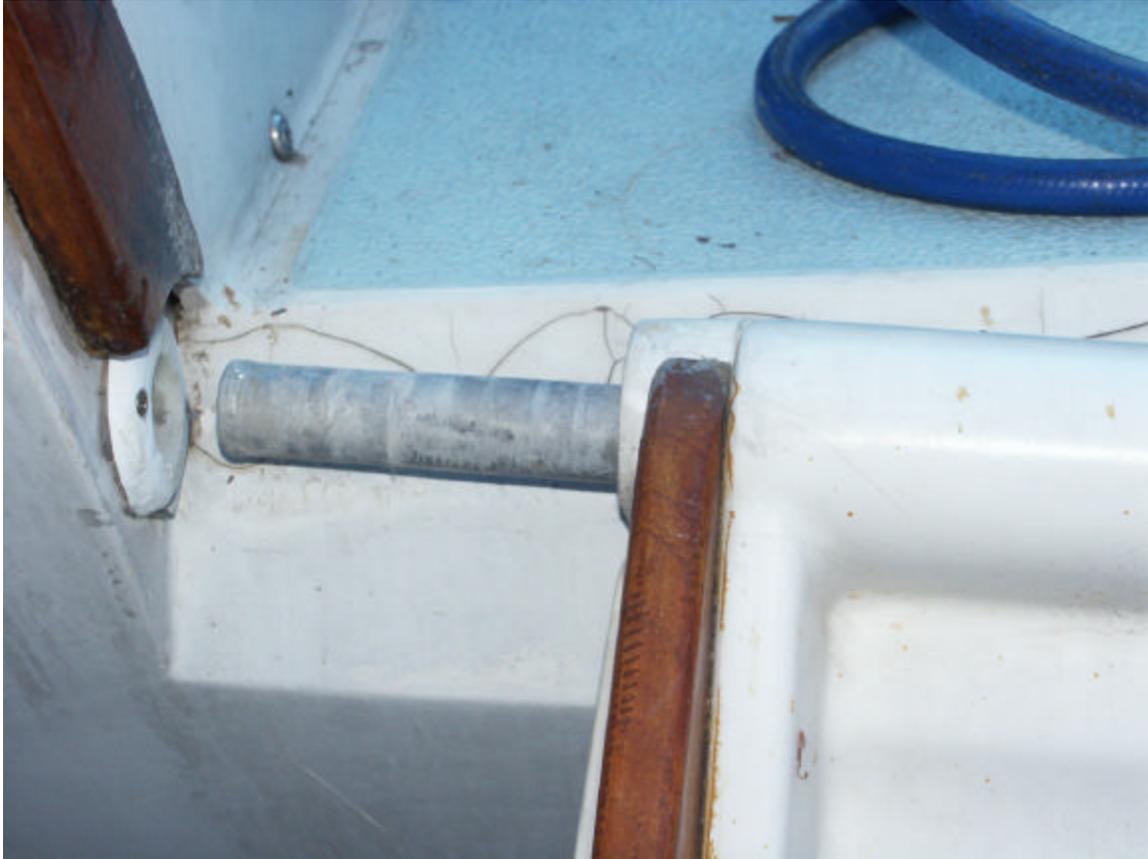
Swim step being removed.

Move the swim step out of the other side and you will have it completely removed.

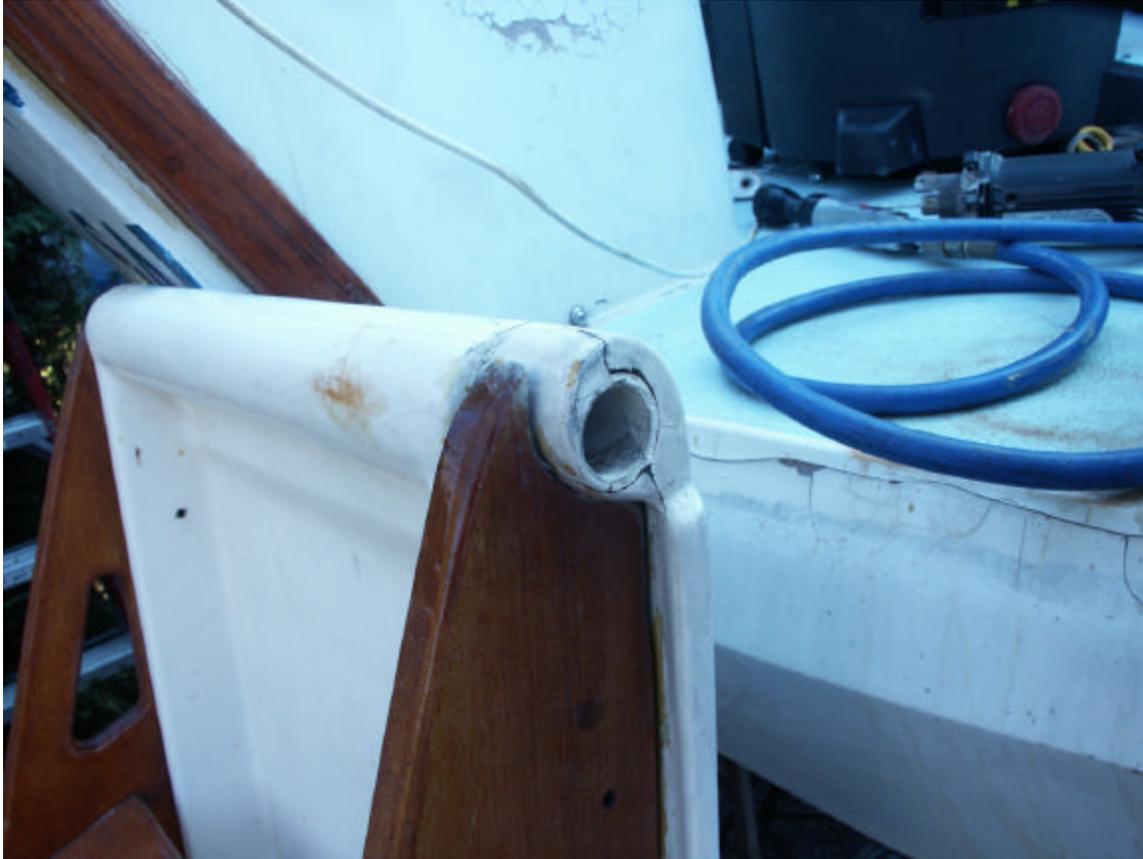
Swim step removed (with pipe removed). Pipe slides out of swim step.

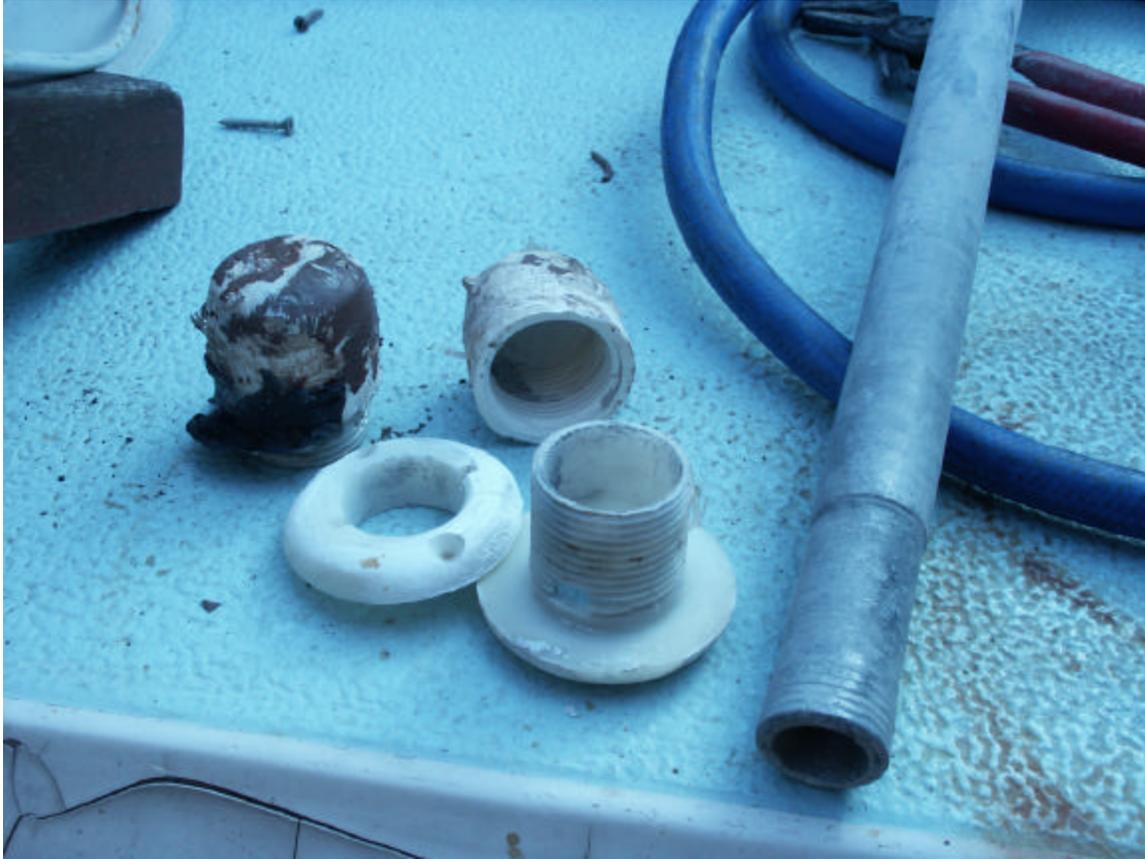
Picture shows old pipe and plastic through-hulls and cap.

In trying to locate new plastic through-hulls I was unable to find any that matched the same diameter as the pipe. The pipe, as you can see in the picture, was also substantially worn. I purchased some new through-hulls and had a friend machine a new solid aluminum bar, where the ends were tapered down slightly to fit the diameter of the new through-hulls. I cut the barbs off the through-hulls, as you will find you need to keep the threads relatively short. The caps were purchased from the plumbing department at Home Depot.

Parts that will need to be replaced:

Two plastic through-hulls

Aluminum pipe

Two caps that screw on the end of the through-hulls (available from plumbing department)

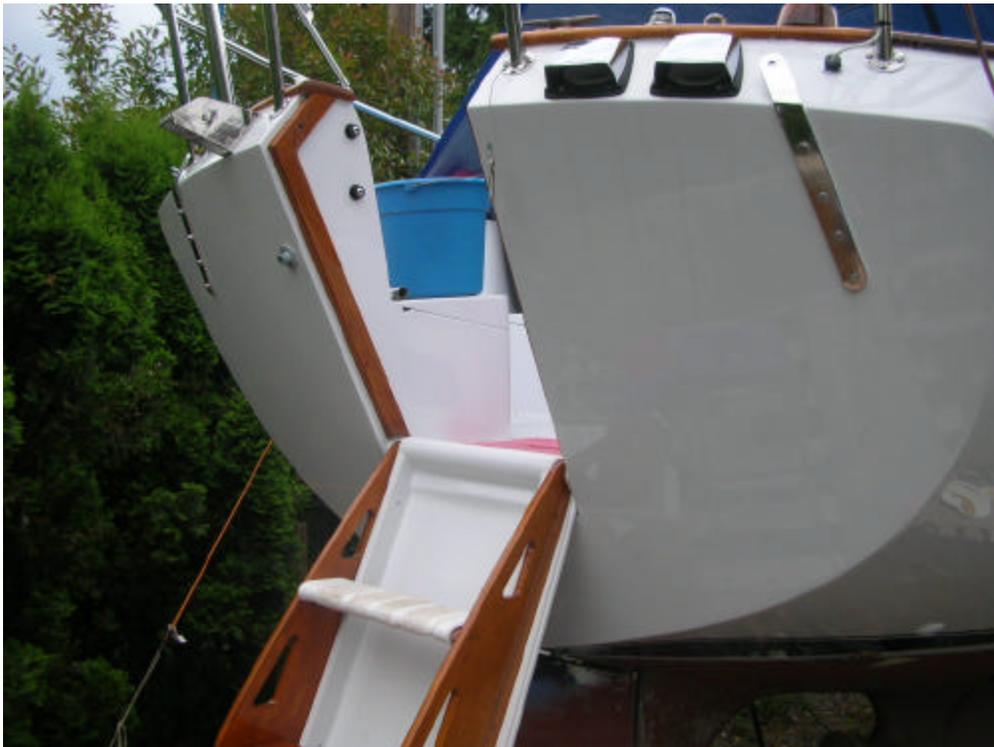
Swim step replaced (after new paint job)

I reassembled the through-hulls using 3M 5200 caulk to bed the through-hulls. I inserted the new bar pipe into the swim step. I used a lithium, high-temperature grease and lubricated the bar and through-hulls. I slipped the swim step and bar into one side of a through-hull, tapped the opposite side all the way through until it was flush with the swim step and pushed the swim set back into place. A helper then tapped the bar with a mallet from the inside of the locker until it started to go through the through-hull on the opposite side. I greased the end caps and screwed onto the through-hulls, which stops the bar from sliding out at either end.
